# CONFEDERATION DRIVE BRIDGE ASSESSMENT & OPTIONS REPORT

Town of Smiths Falls – January 2020

**Keystone Bridge Management Corp.**

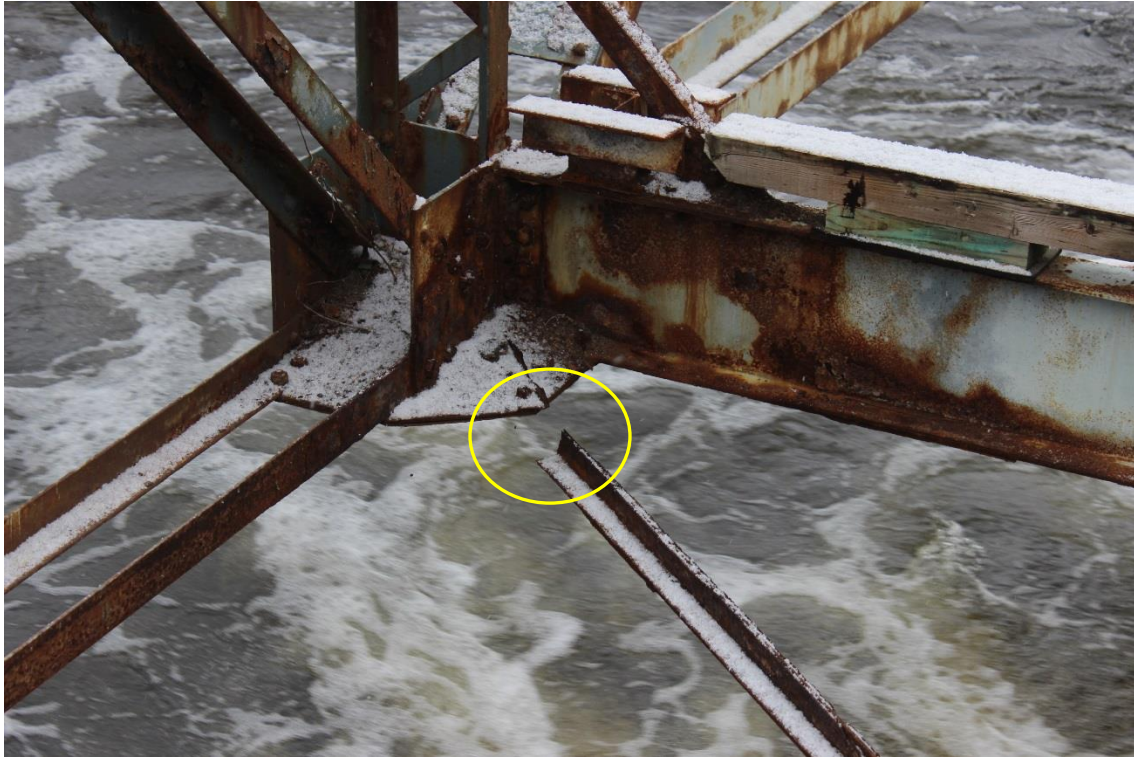
4. One bottom lateral bracing member is severed, see Image 3.
5. The outriggers supporting the pedestrian walkway were only inspected at one location. A perforation at this location pictured in Image 9 means that a more comprehensive inspection of the outriggers is warranted.

**Image 3. West truss panel point 1 downstream severed diagonal brace**

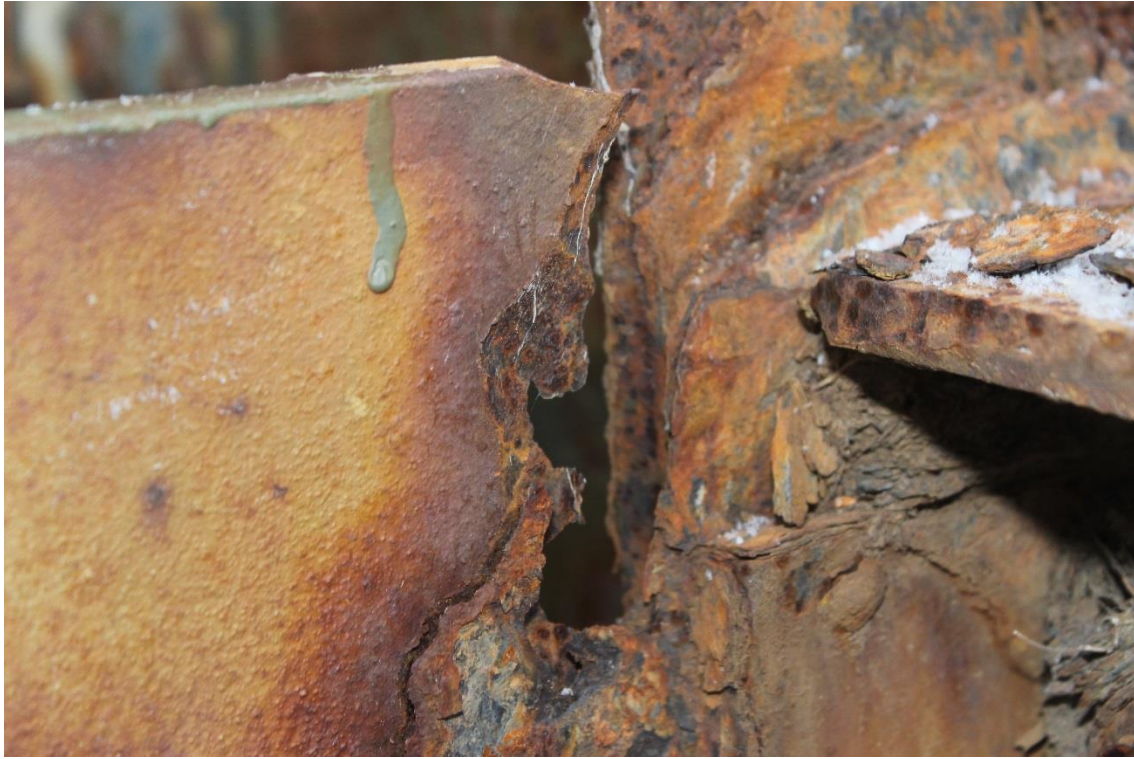
2. The vertical paired gusset plates at the lower panel points appear to have a systemic crevice corrosion type feature on the inboard gussets. The worst example is pictured in appended Image 5.

**Image 5. East truss panel point 4 upstream perforated gusset plate**

It is abundantly clear that all the inboard vertical gusset plates require replacement. It is very likely that all the bottom chord members that were not replaced in 1986 should be replaced if the bridge is to be returned to service. It is evident that the bridge is salvageable.

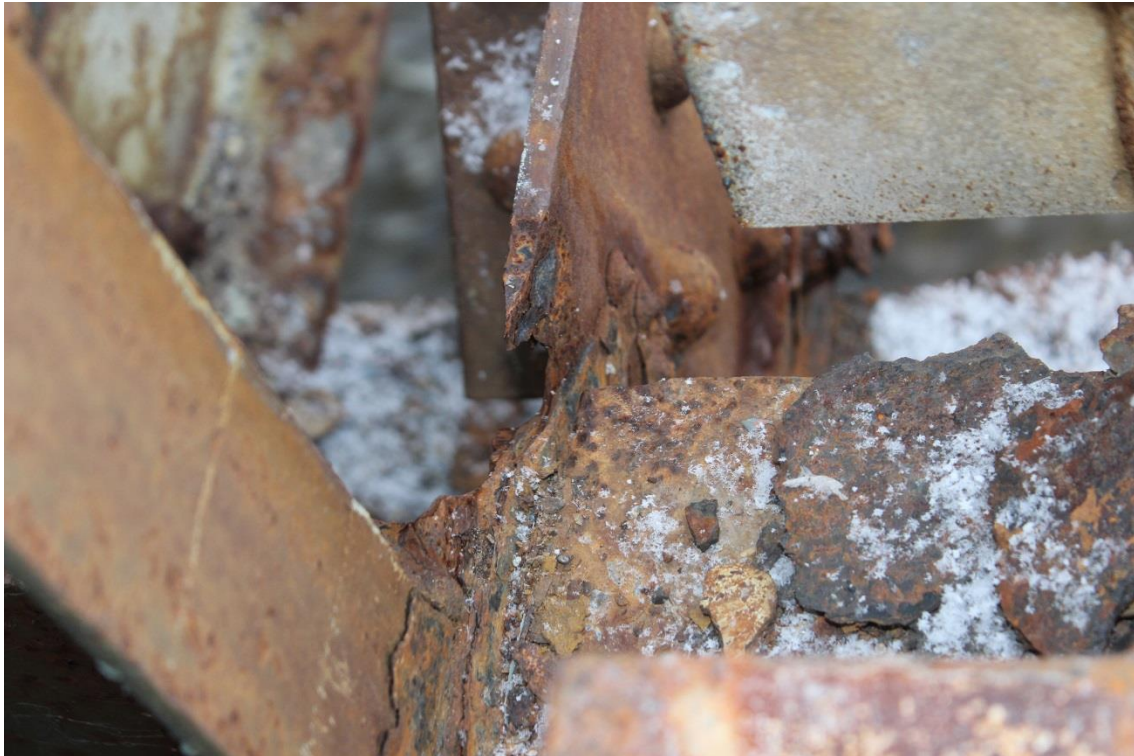
**Image 6. East truss panel point 4 upstream perforated gusset plate**

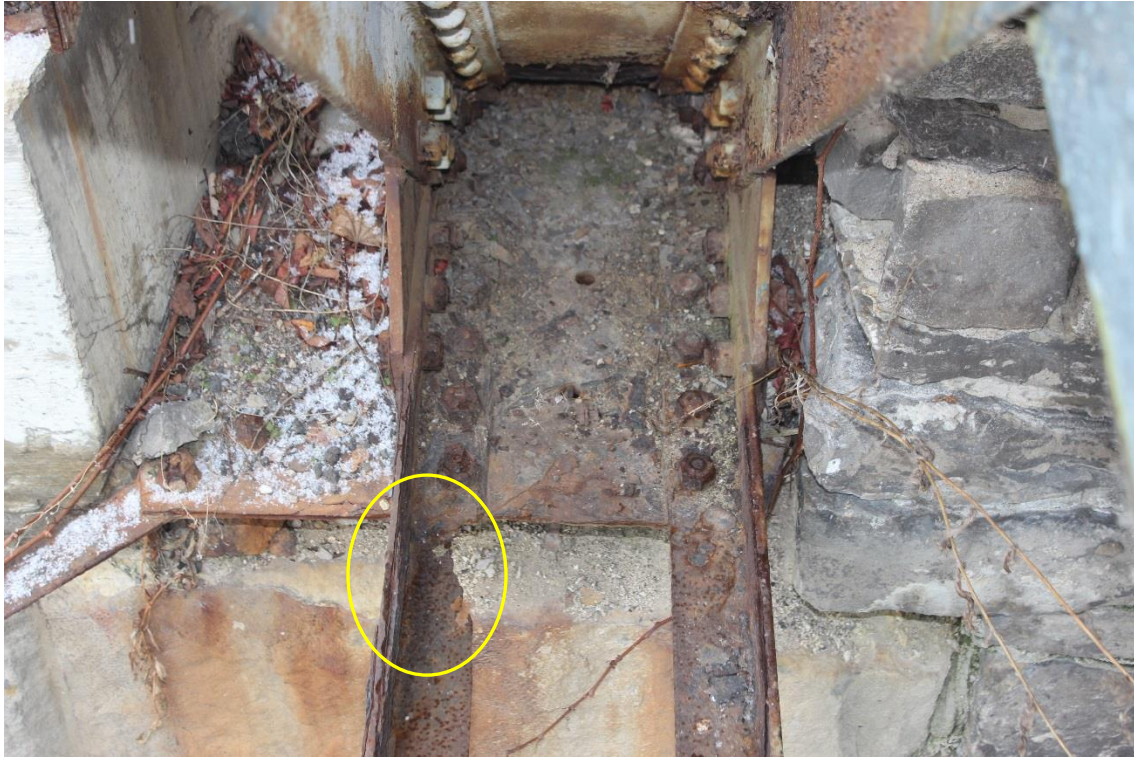
3. There is significant and critical section loss of the bottom chord angles at the SE bearing of the east truss, see Image 7. This is of concern as this member was intended to be replaced in 1986. It is clear from this that unprotected or poorly protected steel in this environment has less than 30 years of service life.

**Image 7.** Perforation, severe corrosion bottom chord east truss SE bearing area

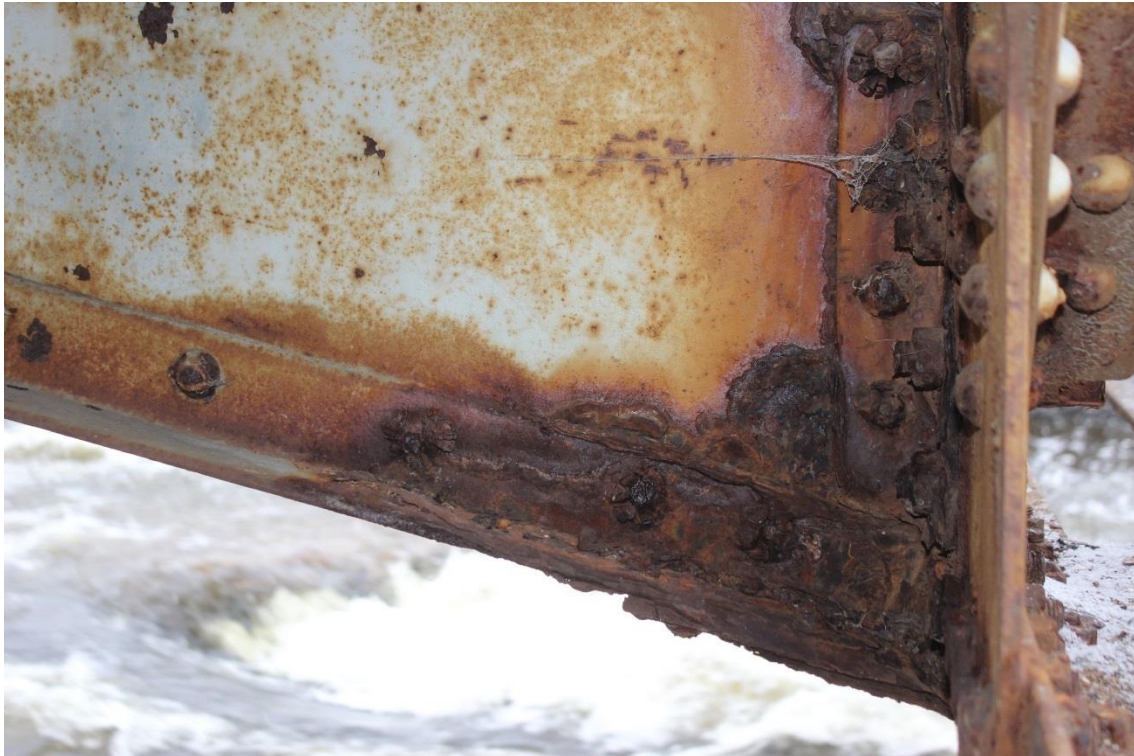
**Image 8.** Corrosion of sidewalk outrigger panel point 4 east truss

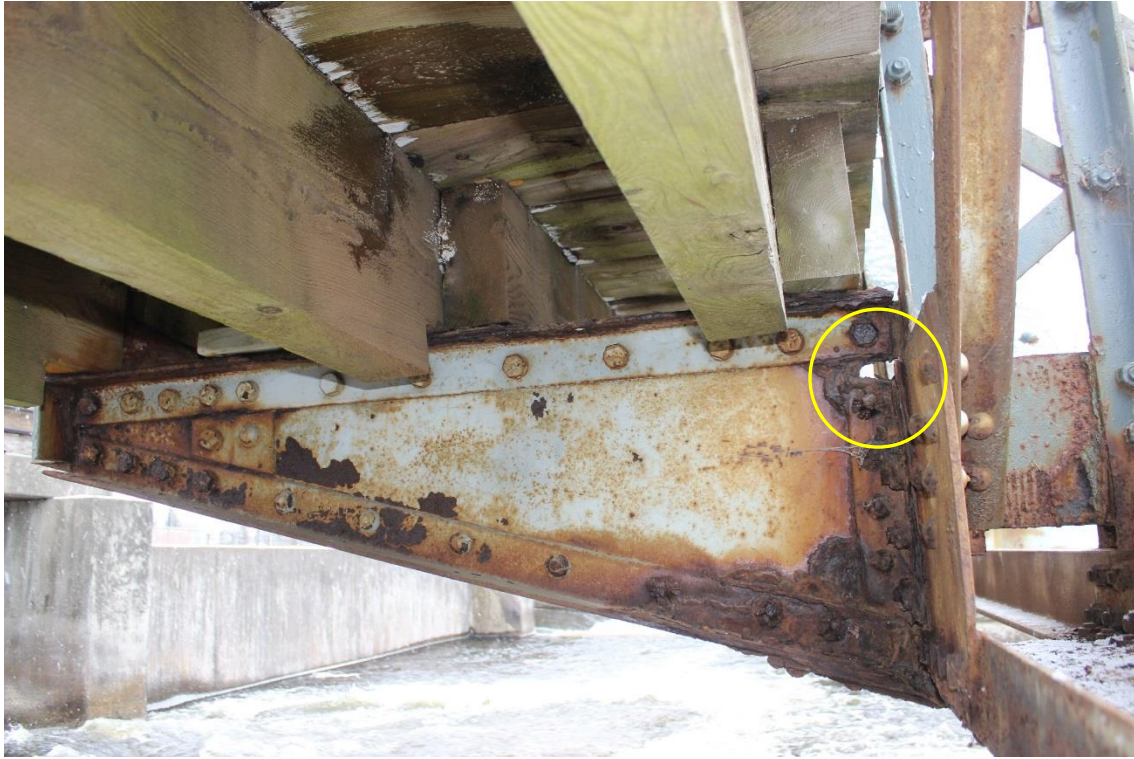
**Image 9. Minor perforation sidewalk outrigger panel point 4 east truss**

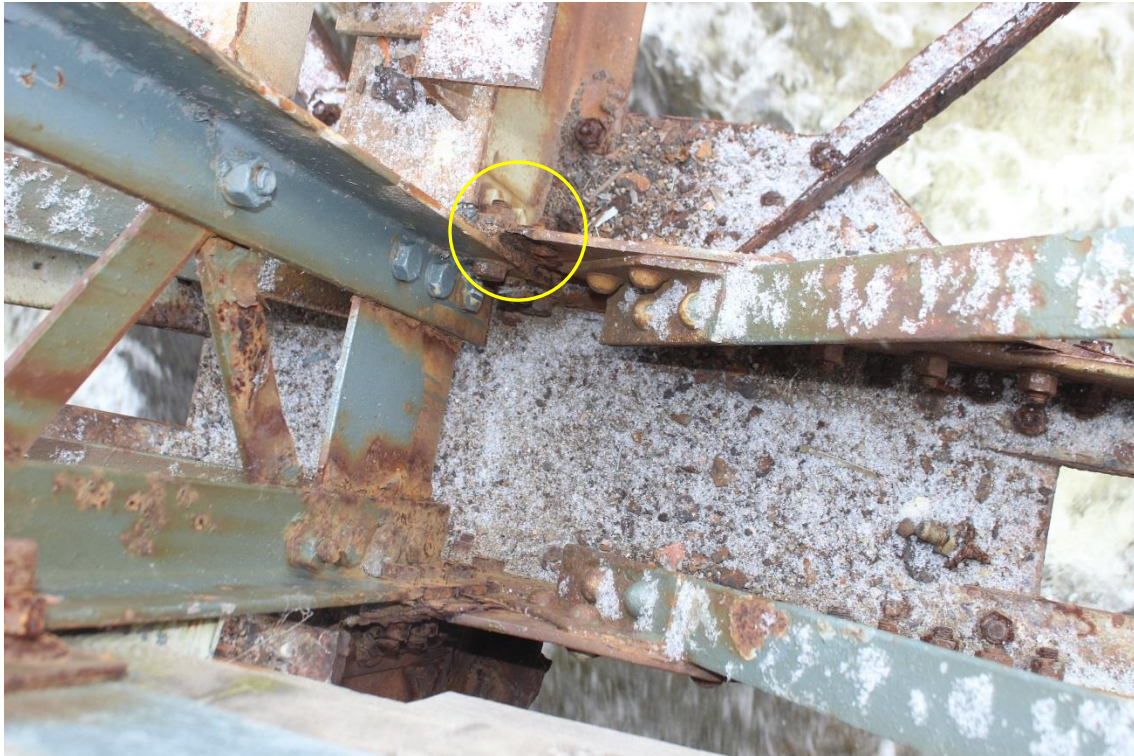
**Image 10. Typical panel point east truss upstream side with gusset thinning**

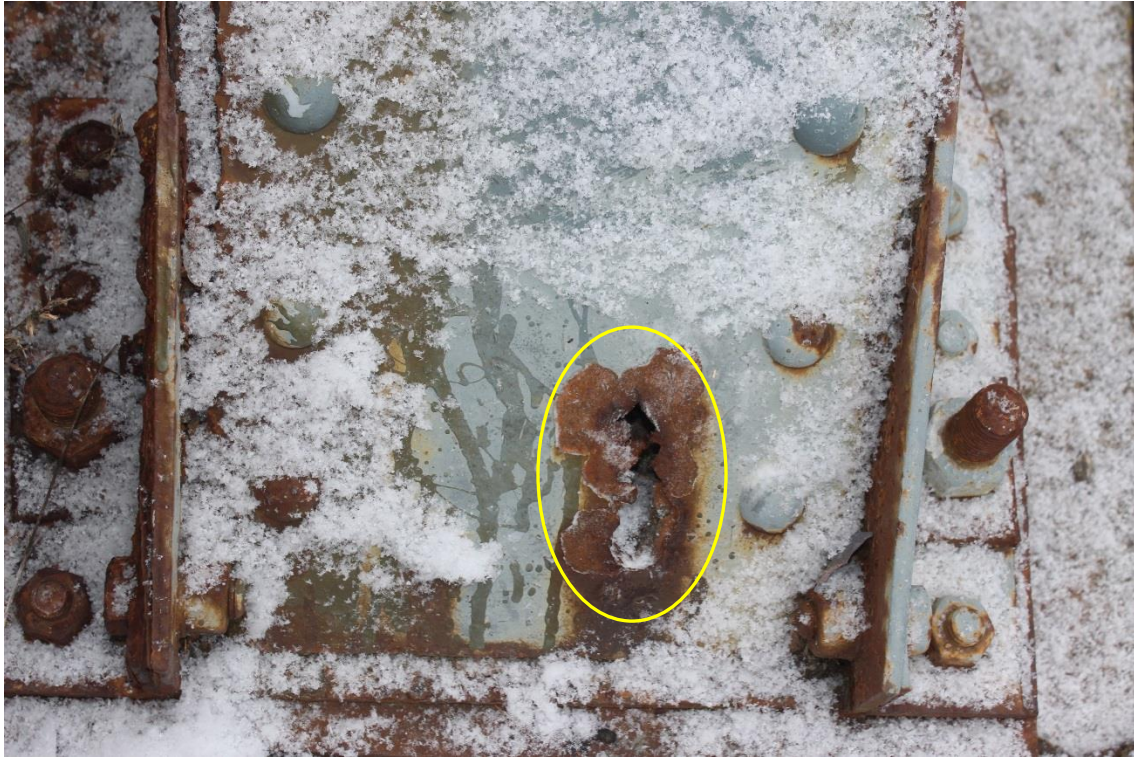
**Image 11.** Perforation of end diagonal cover plate NE bearing west truss

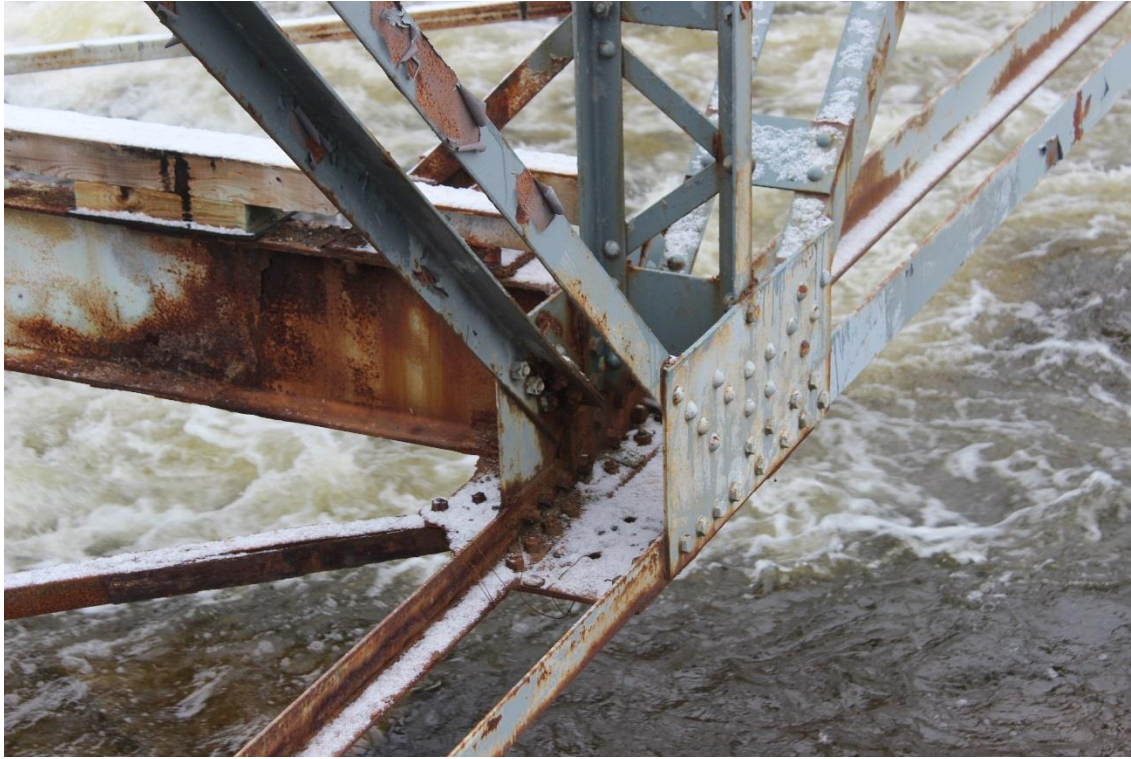
**Image 19. Panel point 4, downstream east truss with rivets & high-strength bolts**
